GREEN SWAMP NO. 3

PHASE I INSPECTION REPORT

NATIONAL DAM SAFETY PROGRAM

NJ 00211

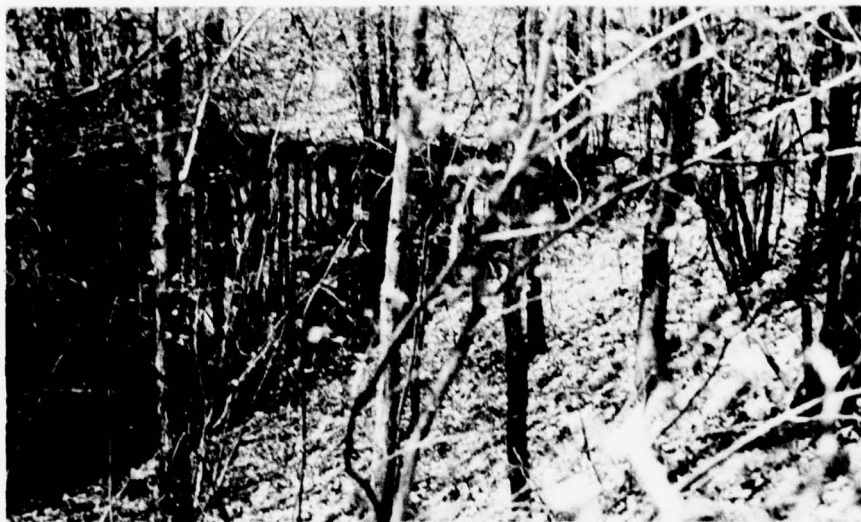
3.1.2 Dam: Some slight sloughing along the downstream slope was observed; the material exposed is mainly silty sand and small gravel. A large size burrow hole was seen on the upper part of the downstream slope, 2-1/2 feet below the crest. The crest of the dam is covered with tufts of grass; shrubs and trees up to 6 inches in diameter cover the upstream slope; trees up to 11 inches in diameter were observed on the downstream slope. A pool of stagnant water is ponded against the downstream slope, to elevation 298 feet. A water depth of 8-9 inches was measured along the perimeter of the pond. At a distance of 250 feet downstream from the pool, water is flowing at an estimated 2-5 gpm with the reservoir water elevation at 302.4 feet.

6.1.1 Visual Observations: The existence of the small swamp with a water level which is higher than the toe of the downstream embankment has raised the phreatic surface within the downstream embankment. The high phreatic surface and poor toe drainage condition presents a potential safety hazard due to long term slope instability which would require further in-depth studies and analyses.

It is believed that the downstream swamp is probably caused by poor drainage condition at the downstream valley bottom and is probably fed by local springs and surface drainage, rather than from steady seepage beneath the dam. However, the supporting evidence must be obtained during a follow-up investigation.

DOWNSTREAM SLOPE WITH POOL OF WATER

7.2.1 Alternatives: In order to drain the swamp at Green Swamp Dam No. 3, the invert of the natural drainage swale could be lowered, or a newer, shorter route chosen (which would include a considerable amount of rock drilling and blasting). An alternate is to drill holes from the downhill side to permit drainage. A subsequent visual inspection of the swamp area should be made when the swamp is drained.

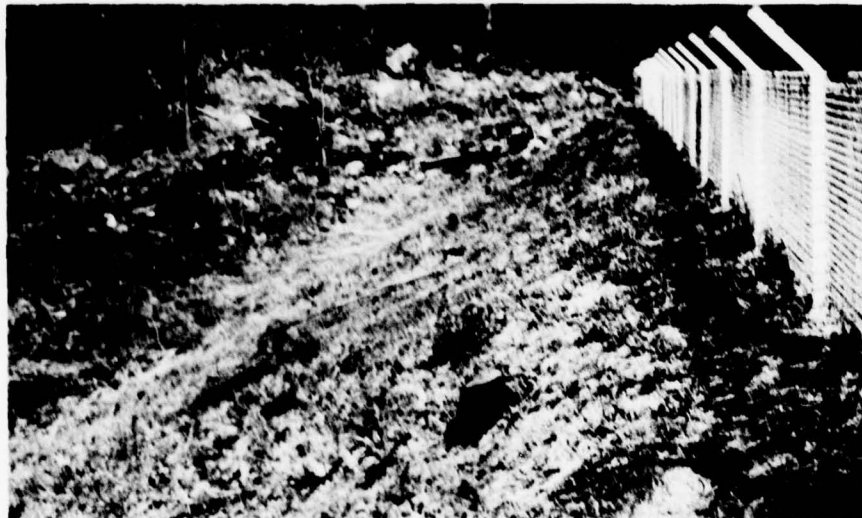
DOWNSTREAM SLOPE LOOKING WEST

7.2.2 Operational and Maintenance Procedures: Clearing of large trees and stumps and prevention of tree growth on the embankment should be performed within the next two years. All burrows in the embankment should be backfilled with select compacted granular material. The cleaned ground surface should be redressed with top soil and seeded with select grass.
